SEI-13036-1
January 2014

Final Report

**VIBRATION ASSESSMENT OF CRITICAL IMAGING SPACES
FOR THE NEW PARKLAND HOSPITAL**

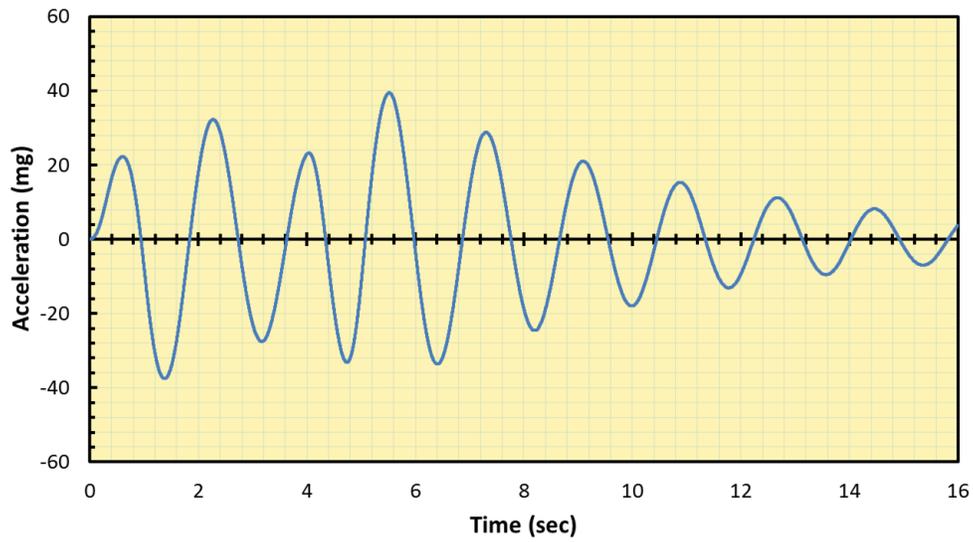
Figure 2-4 Transient Dynamic Gust Response of the Acute Tower at the 16th Floor.

A transient dynamics analysis is performed to determine the lateral acceleration at the location of the CT imager. The Code-specified wind loads are smoothly ramped from zero to the specified magnitude over 0.5 sec and then ramped back down to zero after 3 seconds at the full level. A structural damping level of 5% of critical is assumed. The lateral acceleration time history is plotted in Figure 2-4. The sway motion is dominated by the first mode of the bay at 0.56 Hz and reaches a maximum peak-to-peak acceleration of 75 mg.

The gust response analysis is based upon a Building-Code-specified gust wind speed of 90 mph, which has a 0.14% probability of being exceeded in any given year. The minimum gust wind speed that can impair imager performance is about 75 mph based on the ratio of the calculated acceleration obtained for 90 mph and the permitted acceleration of 51 mg. The return period, T , for a 75-mph gust is

which implies that imager performance may be impaired once every 9 years, assuming the imager operates continuously during those 9 years. If, on the other hand, the CT imager is used 4 hours/day on average, the probability of impaired performance drops to once every 50 years. In other words, it is highly unlikely that wind-induced sway motion of the Acute Tower will affect the imager’s performance in the lifetime of the hospital, let alone the lifetime of the imager.

The General Notes, Ref. [9], state that the CT imager on the 16th floor must be mounted on a vibration isolation system to prevent lateral wind-induced sway motion of the tower from adversely affecting

imager performance. Structural dynamics analyses do show that Building-Code-specified gust wind pressures will give rise to peak-to-peak tower accelerations that exceed the imager's transient vibration requirement. Building Code wind loads, however, are intended for the design of the main wind force resisting system of the building and therefore have a very low probability of occurrence. The analyses indicate that imager performance may be affected only once in the operational lifetime of the imager when gust wind speeds exceed 75 mph while the imager is in use. PHHS may want to consider the need for the vibration isolation system given the very low probability that wind-induced sway motion will affect the imager.

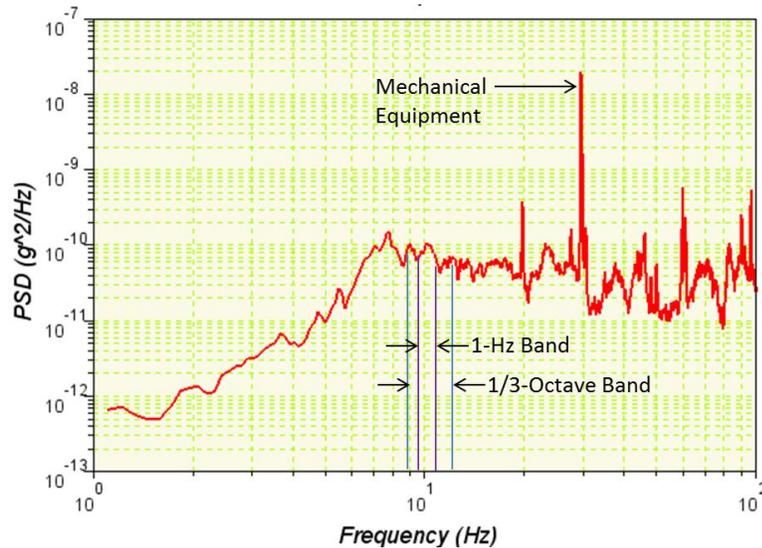
Figure 3-3 Power Spectrum for E4193.

Power spectra show how vibration energy is distributed across the frequency domain. The power spectrum computed from the (mostly) stationary portion of the data measured in E4193 is plotted in Figure 3-3. The stationary portion of the data occur before the two transient events shown in the right-hand side plot in Figure 3-2. The power spectrum is an average of the 8-sec-long data segments (8192 samples/segment). Each segment overlaps the previous segment by 50% (4096 samples). The Hanning data window is applied to each data segment, as required by the vibration specifications, to reduce the effects of leakage. The sampling frequency (1000 Hz) and data segment length (8192 samples) determine the frequency resolution, $\Delta f = 0.122$ Hz, of the power spectrum.

The large-amplitude and very narrow peak at 30 Hz is caused by structure-borne vibration transmitted to the space by the mechanical units located across the corridor in E4100. The other lower-amplitude, narrow peaks visible in the power spectrum are also likely caused by that or other mechanical units in the complex; however, the spike at 60 Hz may be electrical noise produced by the electrical outlet the DAQ is plugged into.

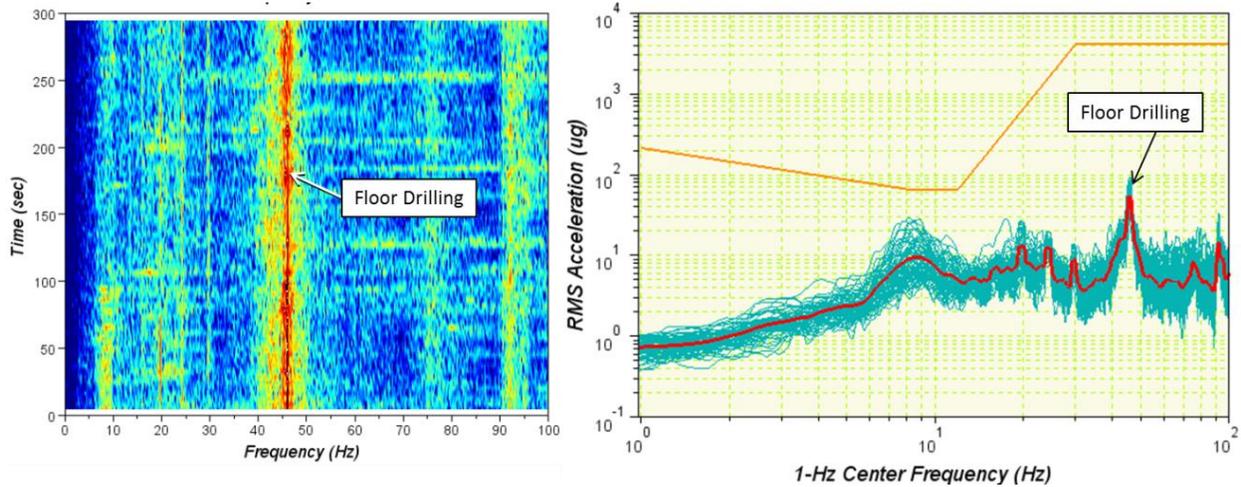
Figure 3-4 Time-Frequency Spectrogram (Left) and Narrowband Spectrum (Right), E2129.

The up-down vibration environment measured in E2129 is represented by the time-frequency spectrogram and the narrowband spectrum provided in the left- and right-hand sides of Figure 3-4, respectively. A high-speed rotary tool (*e.g.*, a drill) was being used elsewhere on the floor and is responsible for the high-amplitude 46-Hz vibration clearly identifiable in the time-frequency spectrogram and the peak at the same frequency in the narrowband spectrum. Even with this non-representative vibration, the averaged narrowband response spectrum (thick red line) falls well below requirement. The narrowband response spectra obtained from each of the 8-sec-long data segments are also plotted in the right-hand-side figure for reference to illustrate the variability of the vibration environment.

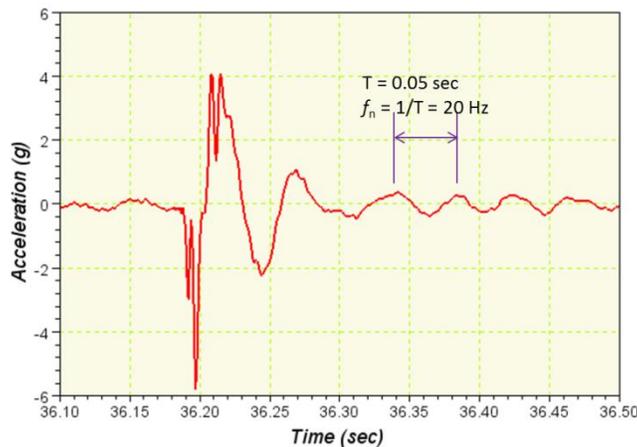
Figure 3-5 E2129 Floor System Response to Heel Drop Test.

The 12-in. topping slab is present in Rooms E2122, E2124, and E2129; hence, a slight increase ($\times 2$) in the vibration environment near the floor’s dominant resonance frequency is expected when the mass of the MRI is added to the floor based on the analysis presented in Section 2.1. The floor response to one of the heel-drop tests conducted in E2129 is shown in Figure 3-5, which indicates that the dominant floor resonance frequency is near 20 Hz. The narrowband response magnitude is about $13 \mu\text{g}_{\text{RMS}}$ at 20 Hz and when doubled to account for the MRI weight is still far below the allowed level of $600 \mu\text{g}_{\text{RMS}}$. Hence, the installation of the MRI will have very little effect on the vibration performance of this room.

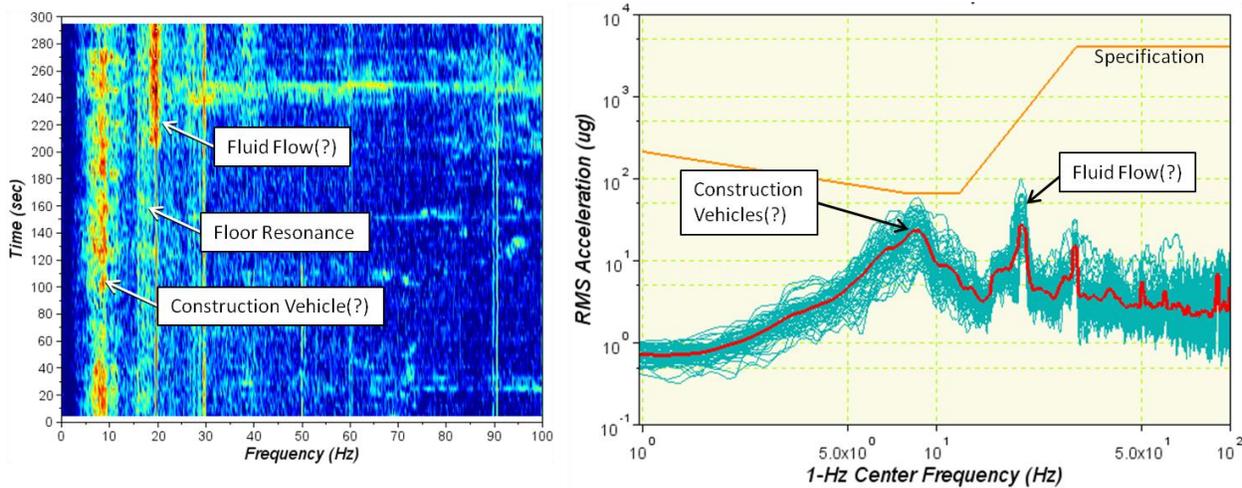
Figure 3-6 Time-Frequency Spectrogram (Left) and Narrowband Spectrum (Right), E2122.

The vibration environment recorded in E2122 exhibits different vibration characteristics from that measured in E2129. The time-frequency spectrogram and narrowband spectrum for this space are provided in the left- and right-hand sides of Figure 3-6, respectively. First, the rotary tool is not operating so the high-amplitude, 46-Hz vibration is not present. However, floor vibration near 8 Hz—the frequency where the MRIs are most sensitive—is much more pronounced than that measured in E2129 about 1 hour earlier. The increased vibration between 6 and 10 Hz may be caused by one or more construction vehicles operating on the south side of

the building. Many vehicles have an axle-hop mode¹ in this frequency range that is responsible for generating ground-borne vibration. This low-rise area of the building may also have a column vibration mode near 8 Hz that amplifies any ground-borne vibration in this frequency range. The column mode, if present, is a characteristic of the building’s construction that will be present when the hospital is operational; however, any vibration created by construction equipment will not be present once all construction activities on the site are complete.

A significant vibration source at 20 Hz appears at 200 sec, which may be amplified by the floor system’s resonant mode(s). The source of this vibration is not known but may be caused by fluid flow through pipes and may therefore be present when the hospital becomes operational. The vibration requirement at 20 Hz is much less demanding than it is near 8 Hz so this vibration source does not raise the concerns that the 8-Hz vibration does.

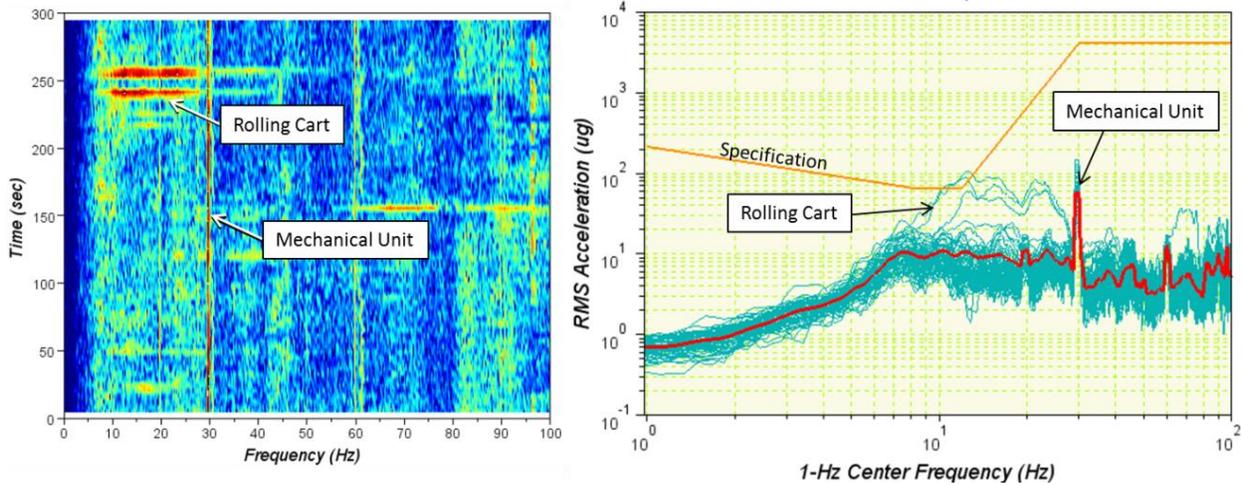
Figure 3-7 Time-Frequency Spectrogram (Left) and Narrowband Spectrum (Right), E4193.

The time-frequency spectrogram and narrowband spectrum obtained from E4193 are provided in the left- and right-hand sides of Figure 3-7, respectively. The topping slab is not present in this room and the analysis presented in Section 2.1 indicates that the effect of the topping slab and MRI weight will only reduce the vibration environment relative to the measurements obtained during the site survey. The time-frequency spectrogram shows evidence of two high-amplitude transient events (rolling cart) and a fairly strong contribution at 30 Hz from the mechanical units located across the corridor in E4100 and/or on the roof above.

The averaged narrowband spectrum is plotted in the right-hand side of Figure 3-7 as the thick red line and it satisfies the MRI specification by a minimum factor of 15. Once again, the individual narrowband spectra from each of the 8-sec-long segments are also plotted for reference. The contribution of the rolling cart transient is evident as the three lines (segment spectra) that rise well above the average response between 10 and 30 Hz. Two of these 8-sec-duration spectra actually violate (*i.e.*, cross) the specification line. This “violation” is not of concern because: (1) the specification is intended to be assessed with an averaged spectrum rather than a short-duration spectrum, (2) the specification level is increased by a factor of 4 (per Ref. [1] and Ref. [2]) for legitimate transient events, and (3) these transient events are not “legitimate” because they result from construction activity rather than normal hospital operations.

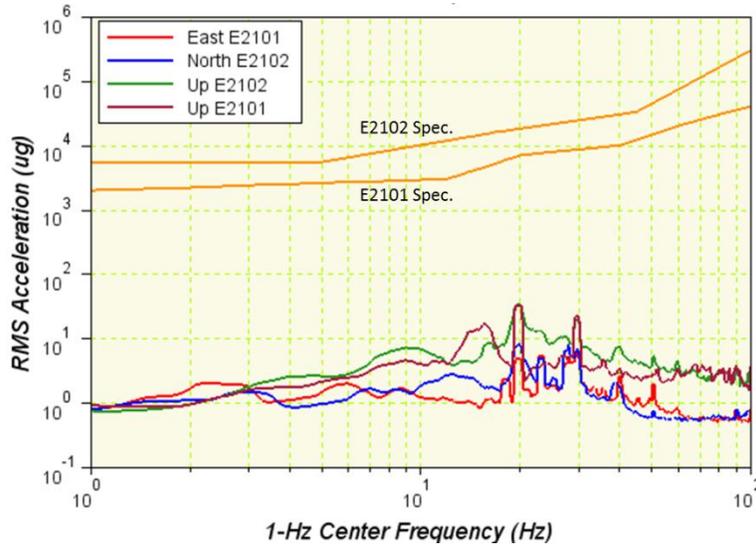
Figure 3-8 Narrowband Spectra from E2101 and E2102.

One of each type of imager, the Flash CT and the AS64 CT, will be placed in E2101 and E2102, respectively. The two rooms are adjacent to one another and the final topping slab was not present at the time the vibration data were acquired. The narrowband spectra obtained in both rooms are plotted in Figure 3-8. The measured vibration levels fall well below the specification limits. As is normally the case, the up-down vibration dominates over the north/south and east/west vibration. The up/down vibration measured in E2102 is generally higher than that measured in E2101 because fluid flow noise around 20 Hz was present during most of the E2102 measurement period. Nevertheless, the flow noise, which is likely to occur during normal hospital operations, does not represent any concern from a vibration perspective and the addition of the topping slab is expected to further reduce the vibration levels in these two rooms.

structure-borne and ground-borne vibration sources are present. Two significant construction transients occurred between 2 and 3 minutes into the data recording period when construction workers set up and then repositioned a ladder in the corridor outside of D16119. These relatively high-amplitude construction transients are identified in the time-frequency spectrogram and are most intense between 50 and 70 Hz. Even with this high-amplitude and non-representative vibration source, the measured vibration environment easily satisfies the requirement.

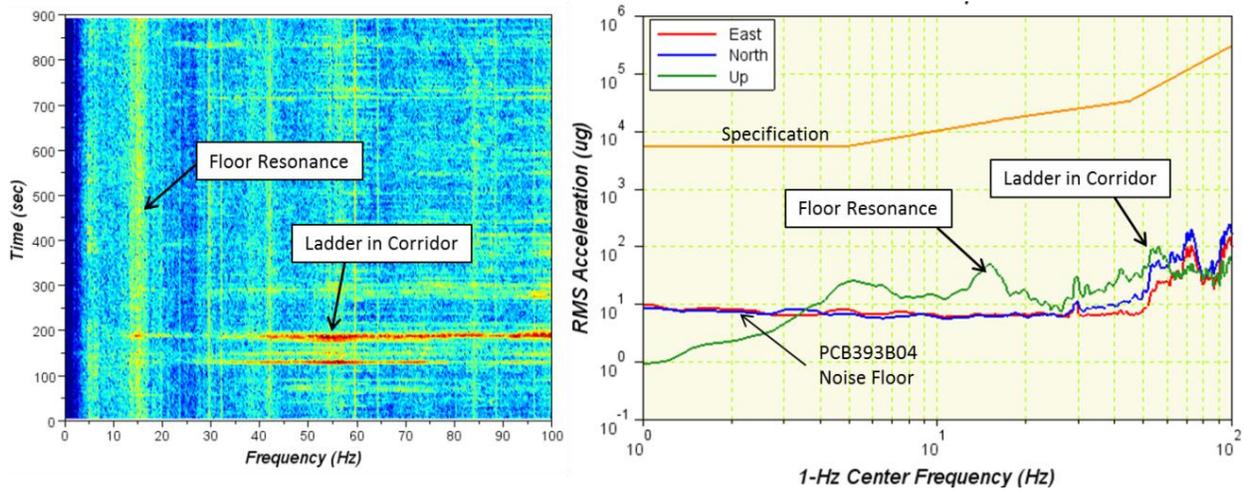
Figure 3-9 Time-Frequency Spectrogram (Left) and Narrowband Spectrum (Right), D16119.

A Somatom Definition AS64 CT imager will be located on the 16th floor of the Acute Tower and is therefore much more susceptible to wind-induced vibration of the tower than are the imagers located on the lower floors. The time-frequency spectrogram and corresponding narrowband spectra are shown in the left- and right-hand sides of Figure 3-9, respectively. The measured vibration does not account for the wind-induced sway motion of the tower because there was very little wind at the time the data were acquired; however, the

No topping slab will be placed in D16119 so the addition of the imager mass (about 5,000 lbf) will tend to increase the vibration level near the floor’s resonance frequency. Persistent floor vibration near its current resonance frequency is clearly visible in the time-frequency spectrogram (left side of Figure 3-9) as the fairly broad vertical band near 15 Hz. The mass of the CT imager is about one-third that of an MRI, so its effect on the resonance frequency will be fairly minimal (about 0.5 Hz lower), and its effect on the floor’s vibration response reduces from $\times 2$ to about $\times 1.5$. The measured vibration near 15 Hz is about $70 \mu\text{g}_{\text{RMS}}$, which may increase to about $105 \mu\text{g}_{\text{RMS}}$ after the imager is installed. Even after taking this increased level of vibration into account, the vibration environment in the room is expected to be 100 times lower than allowed by the AS64 specification. Ground-borne and structure-borne vibration are not expected to pose any problems with imager performance.

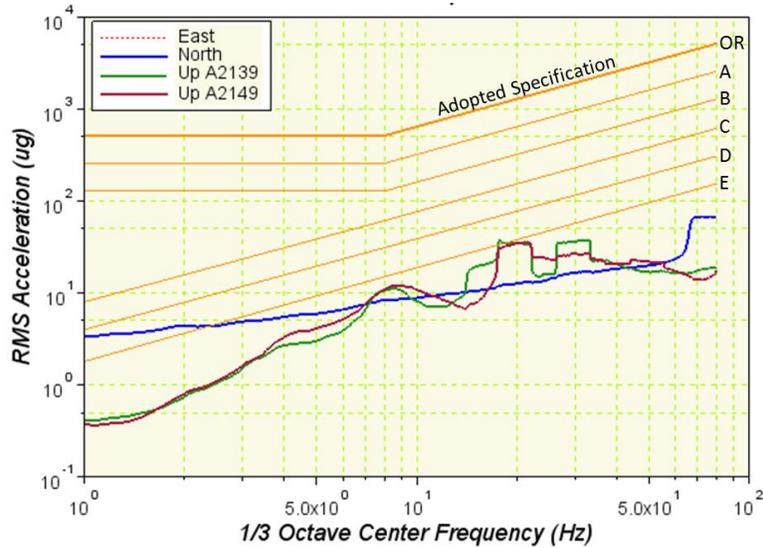
Figure 3-10 Miscellaneous Equipment Evaluation: Rooms A2139 Through A2152.

Rooms A2139 through A2152 are adjacent to one another and the partitions that will eventually separate and define these rooms are not installed. The topping slab is not present; hence, the addition of the equipment will not adversely affect the vibration environment. Given the relative vibration insensitivity of the imagers identified for these six rooms and the identical construction of the floor system in this contiguous space, vibration data are acquired in A2139 and A2149 to represent these six rooms. The 1/3-octave band spectra are shown in Figure 3-10. As expected, the up-down vibration spectra obtained in A2139 and A2149 (about 40 ft apart) are virtually identical. Furthermore, the measured vibration level is about 150 times less than allowed by the ISO specification for operating rooms. The absence of construction activity, including foot traffic in the surrounding corridors provides the most optimistic vibration assessment; however, routine hospital operations will not affect this assessment.

No east/west spectrum is plotted in Figure 3-10 because the wire connecting the accelerometer to the data acquisition module developed an intermittent short at some point during the measurement activity. The absence of data in the east/west direction is not of concern because the vibration level parallel to the floor is

negligible and the adopted vibration specification far exceeds even the worst-case vibration in the up/down direction.

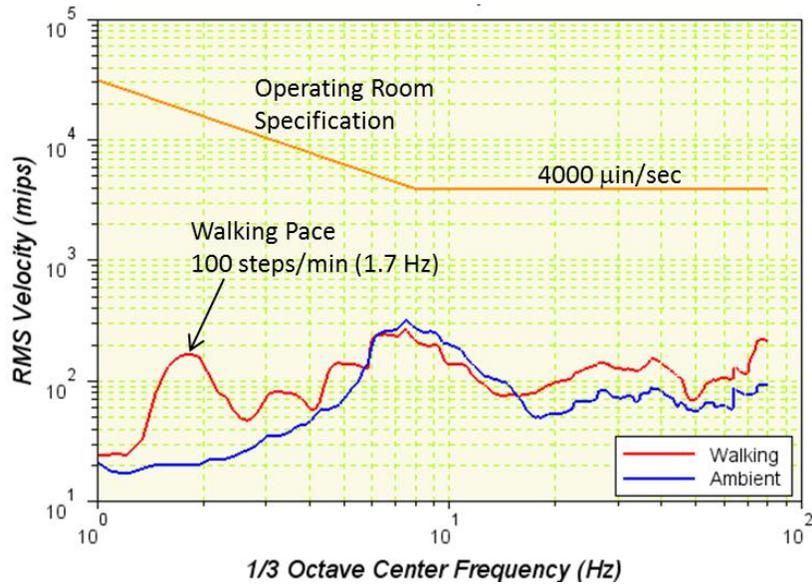
Figure 3-11 Ambient and Walking-Induced Vibration in Corridor C4C01.

A smartphone metronome application² set to 100 beats/min is used to establish the walking pace as data are simultaneously acquired on the floor. The floor (operating room ceiling) RMS velocity, computed in 1/3-octave bands is shown in Figure 3-11 for the ambient vibration (no walking) and the walking-induced vibration environments. The primary effect of the pedestrian traffic in the corridor is evident at the step rate of 1.7 Hz; however, the maximum floor velocity occurs around 8 Hz and is largely independent of pedestrian traffic in the corridor. The vibration near 8 Hz may be caused by ground-borne vehicular vibration and/or vertical “pogo” oscillation modes of the building’s columns. The floor system’s resonance frequencies fall in the 25-Hz range based on heel-drop test data obtained in the corridor. Nevertheless, the maximum floor velocity is about 500 $\mu\text{in}/\text{sec}$ (mips), which is much lower than the 4000 $\mu\text{in}/\text{sec}$ allowed by the ISO operating room vibration specification (and Ref. [9]). Walking-induced vibration will not be noticeable to hospital staff working in the operating rooms below the C4C01 corridor.
