FLOOR VIBRATION ASSESSMENT AND TUNED MASS DAMPER DESIGN FOR A COMMERCIAL OFFICE BUILDING

JAMES (JAY) L. LAMB, PH.D.

OCTOBER 2015

AG&E STRUCTURAL ENGENUITY

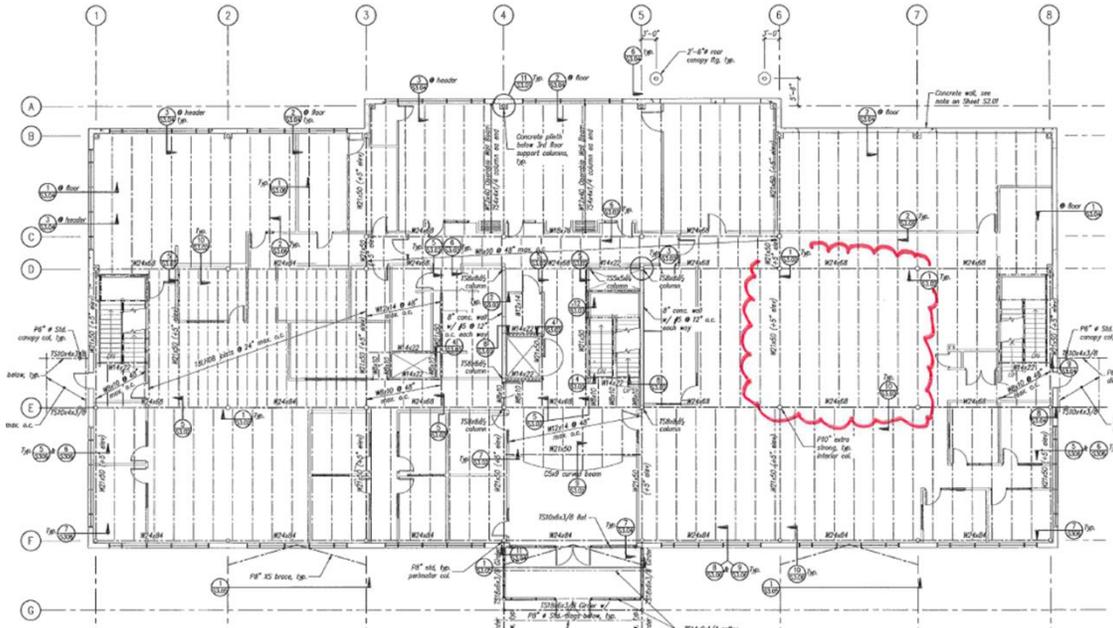
Figure 2 Second Floor Structure With Area of Vibration Concern Identified

The area of concern within the building is the 28-foot by 28-foot interior bay located between Gridlines 6 and 7 (east/west) and Gridlines D and E (north/south) as shown in Figure 2¹. The floor structure consists of 18-inch deep joists (18LH08) that span 28 ft in the north/south direction and are spaced at 4 ft on center in the East/West direction. The joists are supported on W24x68 girders on the north and south sides.

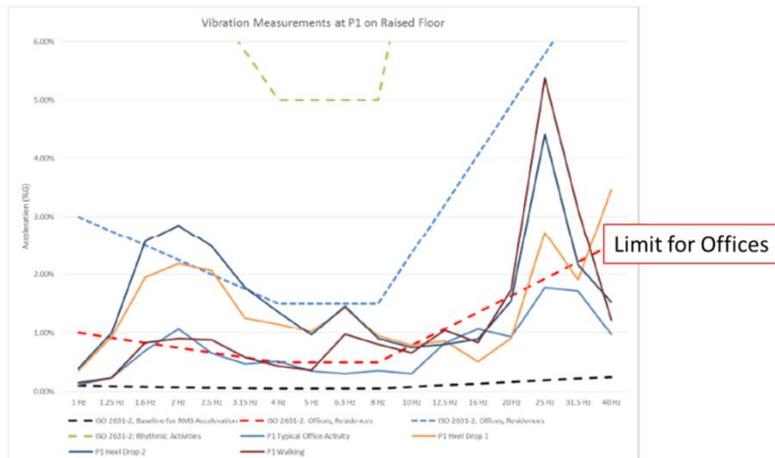
Figure 3 Floor Vibration Measurements

The acoustics firm measured vibration levels at four locations within the bay during their site survey. The vibration levels at the center of the bay [see Figure 3 from Reference (a)] exceed the criteria per Reference (b) for office spaces at three distinct frequencies: 2.5 Hz, 6.3 Hz, and 25 Hz. The results show that walking-induced vibration is the dominant source of the vibration felt by the building's occupants. The findings also clearly indicate the atypical nature of the floor system dynamics at the site. The very low frequency of 2.5 Hz is a very low frequency if it represents a structural resonance frequency. The as-built structure would have to be significantly

different from that shown in Figure 2 for the 2.5-Hz vibration to represent a resonant floor mode. The response near 6.3 Hz is at a frequency most likely to coincide with a structural mode of the floor based on the as-drawn construction. The maximum response is measured at 25 Hz where people tend to be less sensitive to vibration; however, the magnitude of the measured vibration is extremely high and, according to the data, should be quite noticeable. Short of a significant stiffening of the floor structure, it is unlikely that any one mitigation strategy will successfully address the vibration at these three frequencies and the acoustics firm has suggested a multiphase approach for dealing with the vibration at the site.

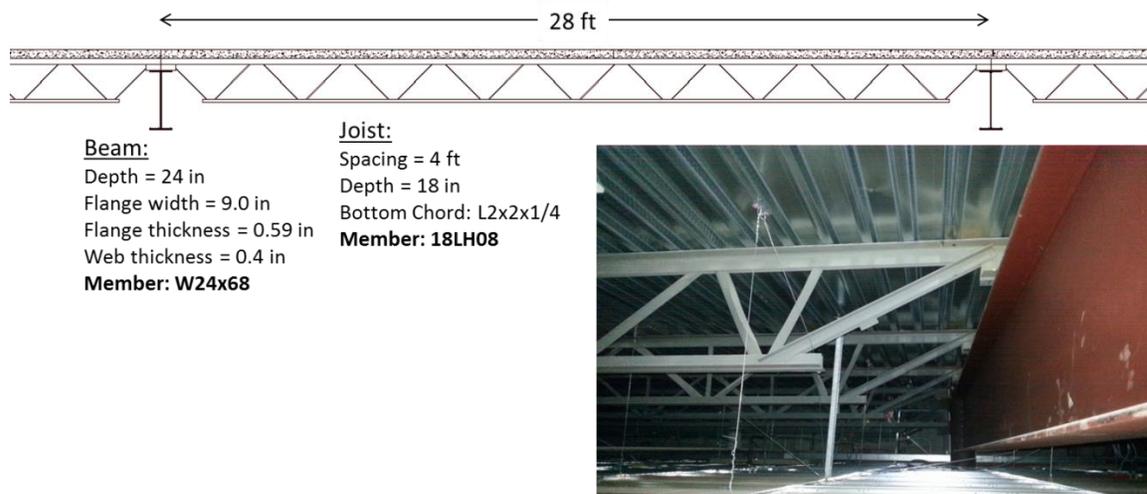
Figure 4 As-Built Floor Structure

Measurements of the structural member dimensions, thicknesses, and spacing are obtained under the bay in question to confirm that the as-built structure is consistent with the structural drawings made available for this project. It is possible that changes in the structure could have been made after the drawings were issued leading to a more flexible structure than that represented in the drawings.

The thickness measurements of the girder flange and web and joist chord were obtained with a Defelsko Positector Ultrasonic Thickness Gauge (UTG). The measured dimensions of the girder are shown in Figure 4. The flange and web thicknesses are consistent with a W24x68 per the documented dimensions ($b_f = 8.97$ in, $t_f = 0.585$ in, $t_w = 0.415$ in). Measurements show that the bottom chords of the joists are constructed from two angles with 2-in-long legs. The thickness of the angles is 1/4" (*i.e.*, L2x2x1/4). The cross-sectional area of an L2x2x1/4 is 0.938 in². The overall depth of the joists is 18 in. and the distance between the center of gravity (*i.e.*, the center of axial force) of the top and bottom chords is 16.83 in. The ultimate bending moment capacity, ϕM_n , of this joist and the corresponding maximum uniform distributed load, w_u , are estimated per the Load and Resistance Factor Design procedure as

The Vulcraft joist design catalog defines the maximum factored uniform load-carrying capability of an 18LH08 joist as 1176 lb/ft for a clear span of 28 ft. The calculated load-carrying capacity of the joists at the site is slightly higher than the documented strength (as it should be); hence, the joists at the site are consistent with the 18LH08 joist identified in the contract documents. The measured joist spacing of 4 ft is also consistent with the contract documents. The as-measured structural members in the structural bay of interest agree with those sections called out in the contract documents.

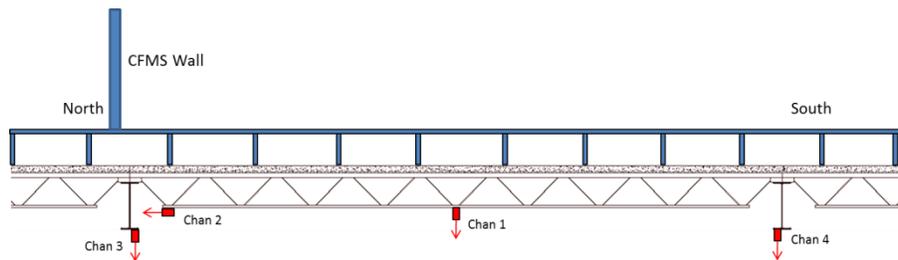
Figure 5 Vibration Measurement Locations on Floor Structure

Two different measurement configurations are employed during the site visit. Initially, the four accelerometers are attached directly to the structural steel members supporting the bay of interest as shown in Figure 5. Channel 1 is located at joist midspan, on the joist closest to the center of the bay and measures the acceleration in the vertical direction. Channel 2 is attached to the bottom chord of the same joist at the north end, but measures the acceleration parallel to the joist span direction. Channels 3 and 4 are positioned on the centerline of each of the supporting girders at midspan and measure the acceleration in the vertical direction.

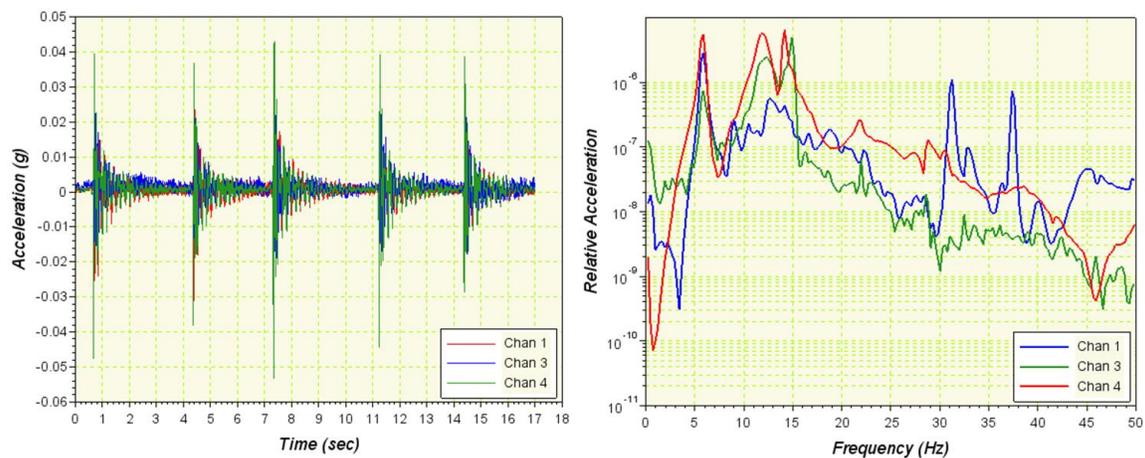
Figure 6 Heel Drop at South Girder: Acceleration Time Series (left) and Frequency Content (Right)

The vertical acceleration time series for five successive heel drops at the south girder are plotted in the left-hand side of Figure 6. The frequency content in the structure's response is shown in the right-hand side of the figure. The Channel 4 accelerometer is located immediately below on the girder where the heel drop test is performed, so it is not surprising that the maximum response is recorded with that accelerometer. The peaks in the frequency domain plot correspond with resonance frequencies of the structure. Dominant peaks at the south girder occur at 5.8 Hz, 11.8 Hz, and 14.1 Hz. As expected for this floor system, the lowest resonance frequency is 5.8 Hz. The 5.8-Hz response measured here corresponds to the 6.3 Hz peak. The acoustics firm's results are documented at the discrete and more coarsely spaced frequencies corresponding to the 1/3 octave bands. In the present analysis, the frequency resolution is 0.24 Hz; hence, the resonance frequency is 5.8 ± 0.12 Hz based on this method of analysis.

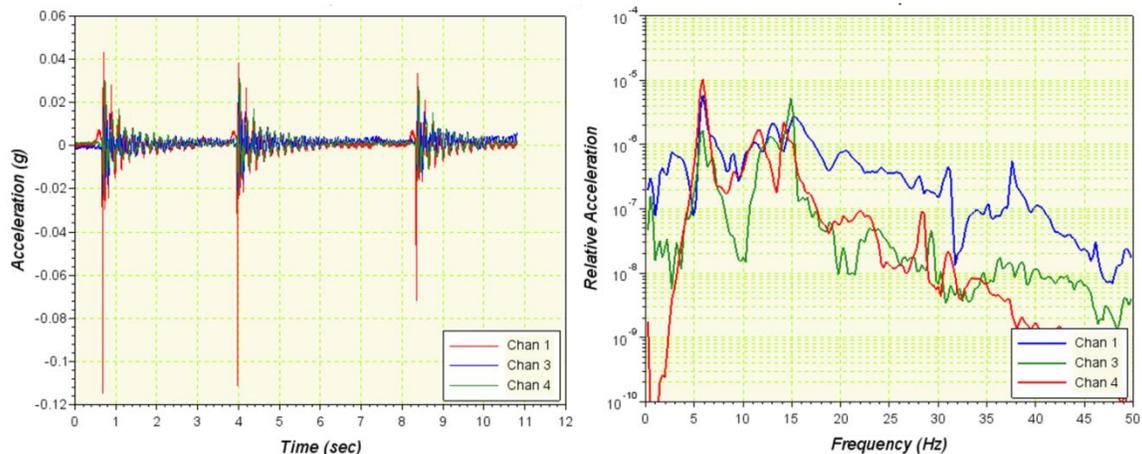
Figure 7 Heel Drop at Joist Midspan: Acceleration Time Series (left) and Frequency Content (Right)

The second series of heel drop tests is performed on the floor slab at about joist midspan, more or less immediately above the Channel 1 accelerometer. The time series for three successive heel drops is plotted in the left-hand side of Figure 7 and the corresponding frequency content is shown in the right-hand side of the figure. Somewhat surprisingly, the response of the south girder is slightly higher than the response of the joist itself. This suggests the flexibility of the girders plays a significant role in the vibration response of the floor system. The north girder response (Channel 3) is much lower than that of the south girder. The non-structural cold-formed metal stud (CFMS) wall, depicted in Figure 5, runs along and parallel with the north girder which stiffens this area of the structure. These relative magnitudes of response provide valuable insight into the structural mode shapes that correspond to the resonance frequencies for the floor system. No new resonance frequencies are identified in the second heel drop test.

One of the transient responses recorded at the joist midspan (Channel 1) shown in the left-hand side of Figure 7 is extracted for the more thorough time series correlation analysis shown in Figure 8. The red curve in the plot is the actual transient response data and the blue curve follows the damped sine formula shown in the figure. A least squares analysis is performed to identify the equation parameters (A , t_0 , f , and ξ) that achieves the best agreement between the data and the equation over the time range shown. The data and the least squares best curve fit are very close (comparing peak/trough spacing and amplitude decay), which implies that the four equation parameters obtained from the least-squares fit are very close to those in the data. The frequency, $f = 5.8$ Hz, and the damping factor, $\xi = 0.03$, are the most relevant parameters, and in this context represent the resonance frequency and damping factor, respectively, for the lowest floor vibration mode. The estimated frequency parameter agrees with that obtained from the frequency domain analysis obtained above.

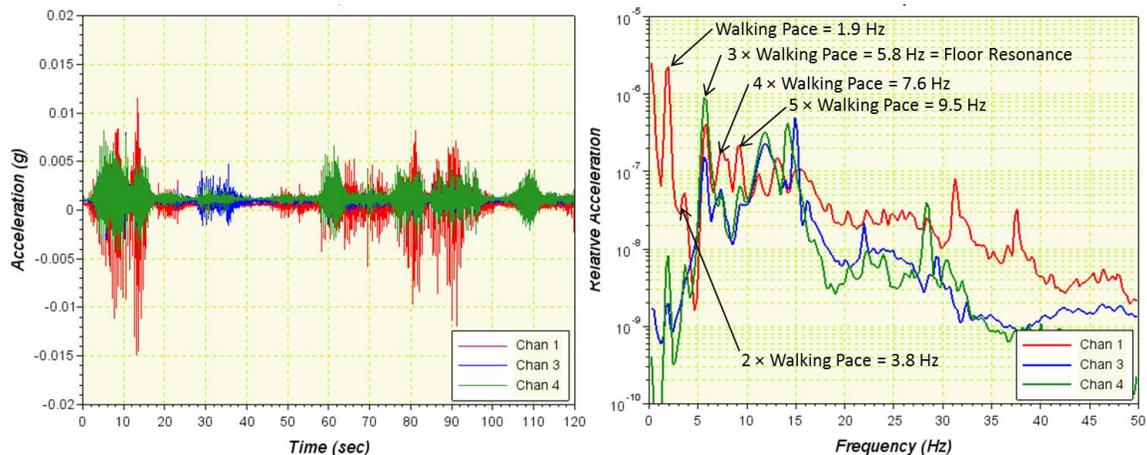
Figure 9 Time Series Acceleration (Left) and Frequency Content (Right) While Walking

The response of the three vertical-oriented accelerometers to walking-induced vibration is shown in Figure 9, where the pace frequency of 116 steps per minute is deliberately selected (and achieved by listening to a smartphone metronome app while walking through the space) so as to maximize the possibility of exciting the floor's resonant mode. The acceleration time series is shown in the left-hand side of the figure and the frequency content is displayed in the right-hand side. Peaks in the frequency domain plot are clearly visible at many of the walking harmonics. The joist-mounted accelerometer is particularly responsive to the fundamental pace frequency of 1.9 Hz. The relative magnitude of this quasi-static (*i.e.*, at a frequency well below the fundamental resonance frequency) response is surprising. The south girder is most responsive at the floor's resonance frequency of 5.8 Hz (*i.e.*, 3×1.9 Hz). The north girder is least responsive. The joist also responds at the higher walking harmonics of 4×1.9 Hz (7.6 Hz) and 5×1.9 Hz (9.5 Hz). The access floor system is contributing to the walking-induced vibration

environment by enhancing the dynamic force magnitudes of the higher walking harmonics. It is doubtful that the vibration response at these harmonics would be so large if people could walk directly on the slab.

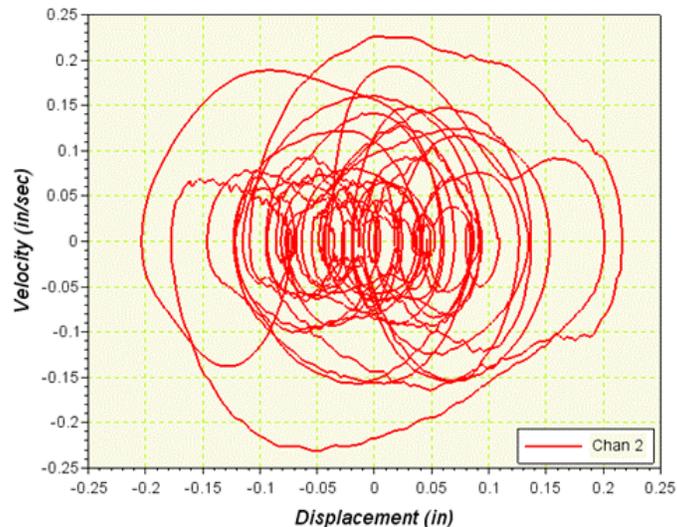
Figure 10 Horizontal Joist Bottom Chord Motion Due to Walking

Occupants of the second floor feel the vertical motion of the floor as others walk through the space and between the cubicles. The fourth accelerometer, Channel 2, is oriented to measure the horizontal component of vibration and is located at the north end of the bottom chord of the midspan joist. One vibration mitigation option

is to attach dampers between the joist bottom chord and the supporting girder. As the joist deflects downward in response to people’s movement above, the bottom chord of the joists translate horizontally toward and away from the girder. A bottom chord-mounted damper would provide an opposing force proportional to the velocity to reduce the motion. The magnitude of the horizontal displacement and velocity of the bottom chord that occurs as people walk on the floor is critical for evaluating the potential benefit that bottom chord dampers might provide. The displacement/velocity time history obtained from Channel 2 while walking on the second floor is plotted in Figure 10. The displacement should be a maximum when the velocity is a minimum and vice versa.

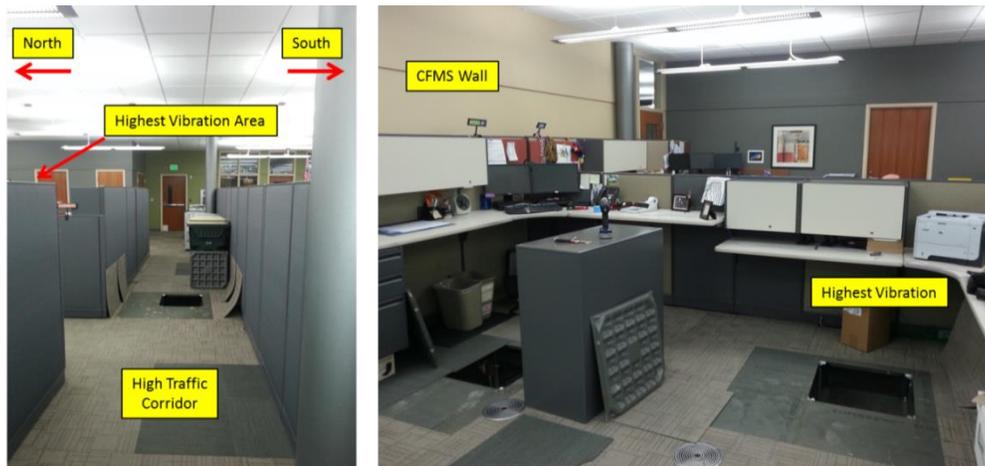
Figure 11 Second Floor in Area of Vibration Complaints: Main Corridor (Left) and Peak Vibration Area (Right)

The second floor of the building in the area of concern is a typical open office plan populated with cubicles that have roughly 4-ft-high interlocking panels that support the desks/working surfaces. Two views of the area are provided in Figure 11. The main east/west corridor (left-hand side of Figure 11) is the high traffic zone and likely the source of most of the vibration. The cubicle area just to the north is where the maximum vibration levels are perceived. The workstation pictured in the right-hand side of Figure 11 (where the printer is) is not currently occupied because the vibration levels have been so annoying. The CFMS wall along the north boundary of the bay is also visible in this picture.

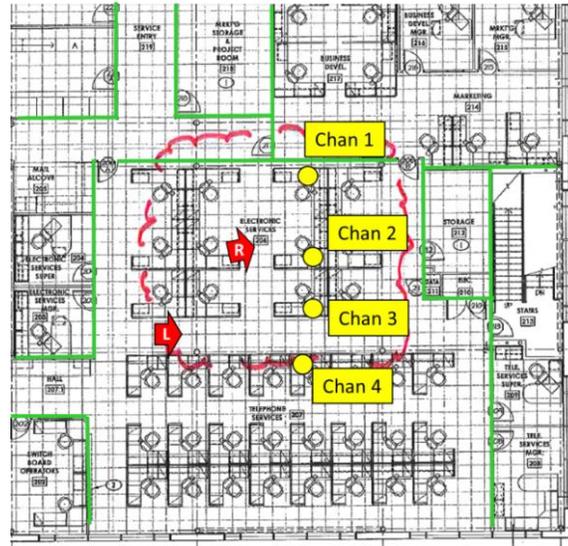
Figure 12 Furniture Plan, CFMS Walls, and Accelerometer Locations on the 2nd Floor

A furniture layout for this area of the building is provided in Figure 12. The red arrows with “L” and “R” show the locations from which the left- (“L”) and right-hand (“R”) photographs in Figure 11 were taken. The green lines represent ceiling height non-structural CFMS walls in the area. The only CFMS wall that has a direct effect on the dynamics of the bay in question is the one that runs along the north boundary. The four accelerometers are repositioned from the steel structure below to the workstations identified in Figure 12. The new locations of Channels 1, 2, and 4 are almost directly above the previous locations of Channels 3, 1, and 4, respectively, discussed in the previous section. Most complaints come from the locations where Channel 2 and Channel 3 are now located. The person sitting where Channel 1 is shown is essentially sitting on the north girder and does not experience joist motion. Likewise, the person sitting where Channel 4 is shown is sitting on the south girder and, to a small degree, on the joist in the next bay to the south.

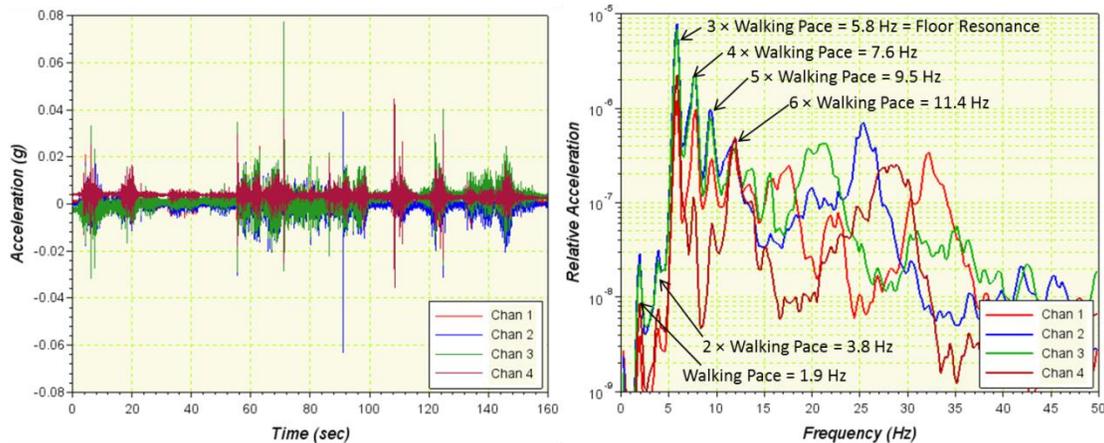
Figure 13 Walking-Induced Vibration: Time Series (Left) and Acceleration Spectra (Right)

Vibration data are recorded while walking around the space (main corridors and between cubicles) at 116 steps per minute (1.9 Hz). The acceleration time series for the four channels are plotted in the left-hand side of Figure 13 and the corresponding acceleration spectra are plotted in the right-hand side of Figure 13. Peaks corresponding to many of the walking harmonics are visible in the spectra. The fundamental walking harmonic at 1.9 Hz is not nearly as prominent in these data (Channels 2 and 3, in particular) as it is in Figure 9 at the joist midspan. Other than the absence of a prominent walking pace spectral peak, the maximum response at all locations corresponds to the fundamental floor resonance frequency at 5.8 Hz. A relatively significant response in Channel 2 is seen near 25 Hz, which agrees to some extent with the original findings, except that the magnitude of the 25-Hz vibration was higher than any other response in the original data. Nevertheless, the presence of the 25-Hz response does suggest a cause/effect relationship with the access floor.

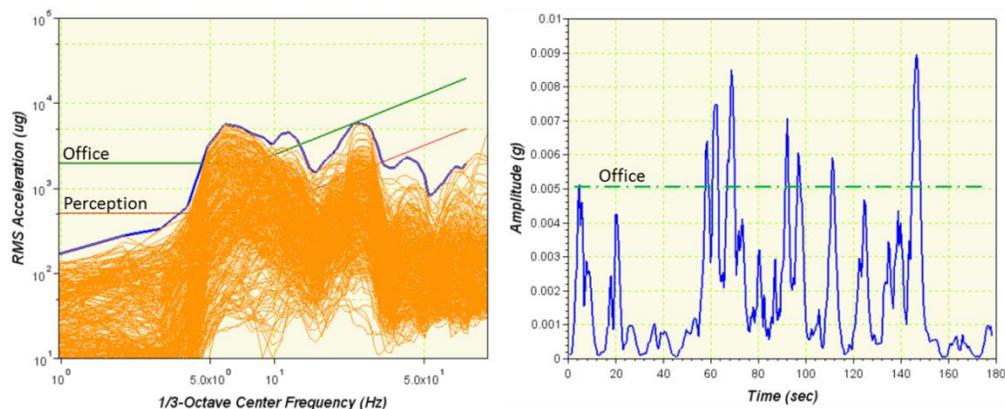
Figure 14 Channel 2 Vibration Response per ISO Criterion (Left) and AISC DG11 Criterion (Right)

Vibration criteria for an office-type occupancy are well documented. The ISO standard accounts for multi-frequency response by considering the vibration in proportional bandwidths that increase in width with the center frequency of the band ($1.23 \times f_{ctr}$). The root mean square (RMS) vibration level in 1/3-octave bands is computed and assessed relative to the “Office” line plotted in the left-hand side of Figure 14. The 180-second long data series is analyzed in 1-sec-long data segments and the RMS acceleration is computed for a continuously-sliding 1/3-octave band and plotted in the figure as a single orange line. This time window is then shifted by 0.5 seconds and the next 1 seconds of data are analyzed. Each orange line represents a 1-sec snapshot of the vibration. This process results in over 360 lines (the orange “band”), from which the maximum response envelope is identified that bounds the total response history (the thick blue line). Where the envelope line crosses the “Office” line is where the vibration exceeds the preferred limit for an office. This occurs between 5 Hz and about 12 Hz. The “Perception” line represents the vibration level than most people can perceive as vibration. According to this interpretation, vibration can be felt from about 4 Hz to 30 Hz. The “Perception” standard is often used for hospital operating rooms and so is not considered a practical limit for office spaces.

The DG11 criterion essentially assumes the source of the excitation is harmonic (*i.e.*, operates with a single frequency) and specifies a peak g-level for different occupancies. An upper bound on permissible acceleration for office-type occupancies is 0.005 g. This criterion is not ideal for real-world data because most real-world sources of vibration, excluding rotating machinery, are fairly broadband in nature. Nevertheless, this criterion is used here for the sake of completeness. For this application, the Fourier transform of the time series is computed over the same 1-sec segments discussed above and the maximum response between 4 Hz and 8 Hz (the 5.8-Hz resonance frequency falls within this band) is plotted versus time in the right-hand side of Figure 14. There are several occurrences where the peak vibration exceeds the 0.005-g limit to a significant degree. Both criteria agree in the sense that the measured vibration exceeds the normally-accepted limits for vibration in an office environment and confirm the original findings for the site as well. The primary cause of the excessive vibration is direct excitation of the fundamental floor resonant mode by the third harmonic of the walking pace. There are additional contributors that tie back to the access floor construction and its tendency to amplify the forces at the fundamental walking frequency (about 2 Hz) and in the higher walking harmonics.

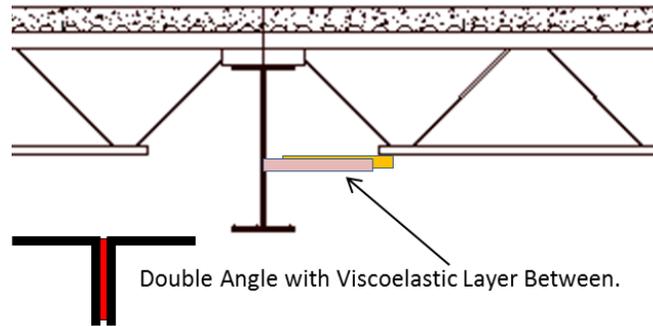
Figure 15 Joist Bottom Chord Damper Concept

Joist bottom chord dampers are evaluated to determine if they can provide a broad-band benefit where the TMDs operate over a very narrow frequency band. The concept of the bottom chord damper is shown in Figure 15. Ideally, the damper only produces an axial force proportional to velocity and no force proportional to displacement. Joist bottom chords are not designed to support significant compressive forces as would be produced if a solid steel member were placed between the girder web and the joist bottom chord (force proportional to displacement). In this case, the force must be transmitted through a viscoelastic layer which will protect the joist chord from excessive compression forces.

A simple model of the floor system is created to assess the contribution of joist bottom chord dampers attached at both ends of the joist as a dynamic force is applied at joist midspan. A typical damper might have a damping coefficient of 270 lbf/in/sec. The maximum horizontal tail velocity of a joist is measured at around 0.25 in/sec (per Figure 10) while walking on the second floor. This velocity will produce a maximum force of only 67 lbf for a normal walking pace. The hope is that the joist bottom chord dampers might be able to reduce the quasi-static (much lower than the resonance frequency) response of the floor at the typical walking pace. The deflection of a joist to the force exerted by a person at midspan in the first walking harmonic, δ_p , and the opposing deflection produced by a joist bottom chord damper, δ_D , are given by

The ratio of the quasi-static displacements provides a rough estimate of the benefit provided by the joist bottom chord dampers. Using the geometry of the joists at the site and estimated damping force determined from the measure joist bottom chord motion, joist bottom chords will only provide about a 10% reduction in the joist displacement (and Acceleration). As 90% of the motion would remain, the joist bottom chord dampers are not considered to be efficient enough to warrant their fabrication and installation cost.

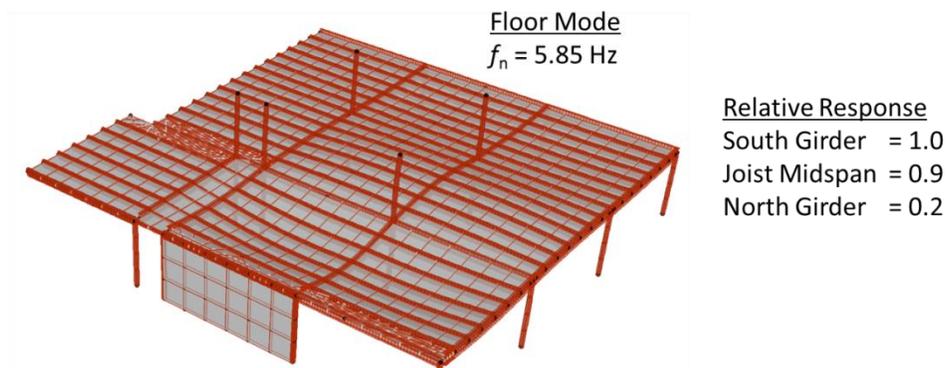
Figure 16 Finite Element Model and 1st Floor Vibration Mode

The heel drop test results provide valuable insight into the primary vibration modes of the floor system. A finite element-based structural dynamics model of the structure is required to provide additional insight into the floor's vibration characteristics that can then be incorporated into a lower-order model of the floor system for assessment of the TMD mitigation option. SAP2000 is used to model the east side of the second floor as shown in Figure 16. The stiffness and distributed mass along the north girder are increased to account for the presence of the CFMS wall and fully composite stiffness properties of the joists are assumed. No moment continuity between the girders and the columns or between the joists on either side of the girder support is assumed. A superimposed mass of 20 lbf/ft² is assumed to account for the occupants, the raised access floor, and the cubicles. The computed 1st mode resonance frequency is 5.85 Hz, which agrees with the measured frequency and the relative response amplitudes shown in the figure are in general agreement with the relative magnitudes measured during the heel drop tests.

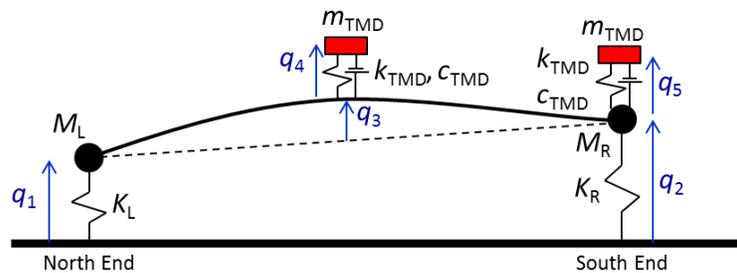
Figure 17 Five-Degree-of-Freedom Floor Dynamics Model

A reduced degree of freedom structural dynamics model is developed from the finite element model for the purpose of identifying TMD properties and to predict the vibration mitigation obtained from the TMDs. A 5-degree-of-freedom (5-DOF) dynamics model is shown in Figure 17. Degrees of freedom q_1 , q_2 , and q_3 describe the floor deflection (q_1 and q_2 represent the deflection of the north and south girders, respectively, and q_3 represents the additional deflection associated with bending of the joists). Degrees of freedom q_4 and q_5 describe the motion of the TMDs relative to the floor. Based on the floor vibration survey, the north girder does not exhibit as much motion as the south girder and joist midspan; hence, the most effective locations for the TMDs is at joist midspan and at midspan of the south girder.

The equations of motion are derived for the 5-DOF model shown in Figure 17 using Lagrange's Equations and provided as the coupled system of 2nd order ordinary differential equations shown in Equation (4) for a dynamic force applied at joist midspan. The spring stiffness at the north and south ends is derived from the flexural stiffness of a 28-ft-long W24x68 steel beam. The stiffness of the north beam and the lumped mass, M_L , is increased to account for the stiffening and mass effect of the CFMS wall at that end of the bay.

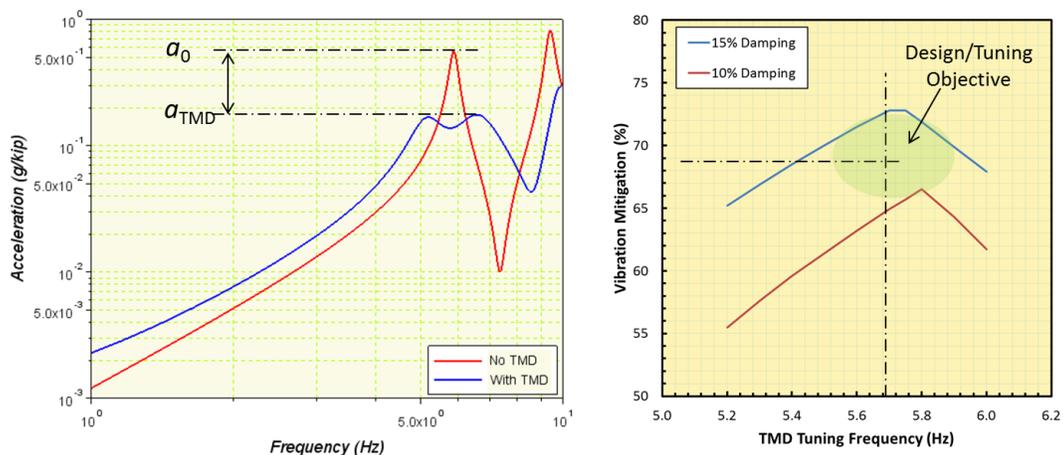
Figure 18 Frequency Response Characteristics (Left) and TMD Efficiency (Right)

The coupled differential equations must be solved numerically to evaluate the response of the floor with and without the TMDs. Numerically efficient modal superposition techniques cannot be used to solve these equations because the damping matrix, with the c_{TMD} parameters included, will not be diagonalized by the modal matrix. Equations (4) must be solved via direct numerical integration. The equations are implemented in SciLab 5.5.1 and the built-in `ode()` solver is used to obtain the time series response of the structure to a simulated heel drop event. The response and heel drop pulse are converted into the frequency domain and divided (response/input) to obtain the frequency response of the structure with and without the TMDs. The comparison is shown in the Left-hand side of Figure 18 with $f_{TMD} = 5.7$ Hz and $\xi = 0.15$.

The addition of the TMDs tuned very close to the floor mode resonance frequency produces two modes. One of the modes has the TMD mass moving in phase with the floor at the lower frequency and out of phase at the higher-frequency mode. The two peaks in the blue curve in the left-hand side of Figure 18 are the resonance

frequencies of these in-phase and out-of-phase modes. The vibration mitigation provided by the TMDs can be estimated from the difference in peak response of the floor without TMDs, a_0 , and the maximum response of the floor with the TMDs, a_{TMD} , per

If the maximum floor acceleration in the vicinity of the original floor mode frequency is equal to the floor acceleration before the TMDs are added, the calculated Mitigation Efficiency per Equation (5) is 0%--no mitigation. If the maximum acceleration of the floor is 0 g after adding the TMDs (impossible), the mitigation efficiency is 100%. Hence, the Mitigation Efficiency varies between 0% and 100%. The mitigation Efficiency for two practical TMD damping factors is plotted for a range of TMD tuning frequencies near the ideal tuning frequency in the right-hand side of Figure 18. A green oval is drawn to indicate the range of tuning frequencies and resulting vibration mitigation that can be achieved with a TMD mass of $m_{TMD} = 1300$ lbm. The goal of the TMD design effort is to produce physical TMDs that provide this mass, tuning frequency (stiffness), and damping. The practical maximum vibration mitigation that is possible for a reasonable TMD mass falls between 65% and 70%.

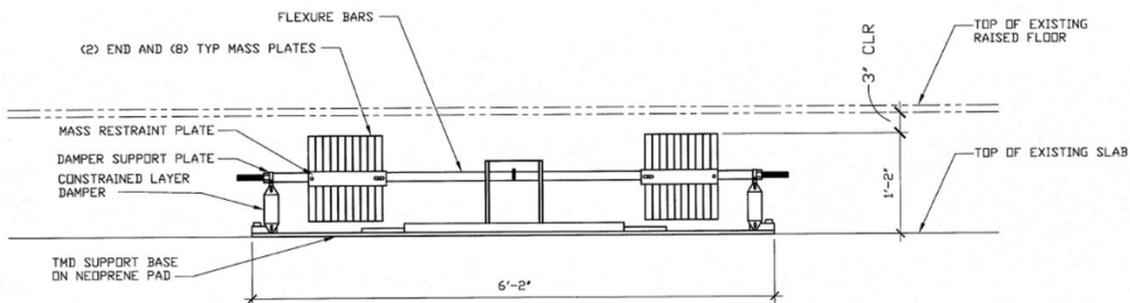
Figure 19 TMD Design Elevation

A TMD can take many forms. The design objective is to provide the mass, stiffness, and damping properties required to achieve the vibration mitigation objective and to maximize the ease of installation. In this case, there is a raised floor and the slab below is essentially clear of any obstructions, so the TMDs can be simply placed on the slab under the raised floor. A side view of a typical TMD is shown in Figure 19. The TMD mass is in the form of ten 12 in by 19 in 1-inch-thick steel plates (64 lbm each) that slide onto the ends of the two flexure bars. The plates can be positioned to adjust the flexibility of the bars, which controls the TMD resonance frequency.

Constrained-layer dampers are attached to each end of the flexure bars to provide the desired level of damping. The constrained layer dampers are constructed from two 16-gage plates with a viscoelastic layer sandwiched between the two plates. The viscoelastic element is a 3-in wide by 0.5-in high by 0.5-in thick block of E-A-R ISODAMP C-1002. Damping is provided by shearing the viscoelastic material across the 0.5-in thickness. The damper also adds stiffness to the system which must be compensated for by increasing the flexibility of the flexure bar-mass system (*i.e.*, sliding the mass farther out along the flexure bars). This damper construction provides a typical damping factor of around 12% which is within the target design range considered in the right-hand side of Figure 18.

Four TMDs are fabricated per the design shown in Figure 19 by Johnston Products of Dallas. The four TMDs are placed within the bay in question as shown in Figure 20. This arrangement is consistent with that shown in the dynamics model in Figure 17. No TMDs are placed on the north girder because the CFMS wall effectively reduces the motion of that girder relative to the joist midspan and south girder. The nominal weight of the TMD is documented as 1600 lb; however, the sprung weight (effective TMD mass) is about 1300 lbf per TMD.

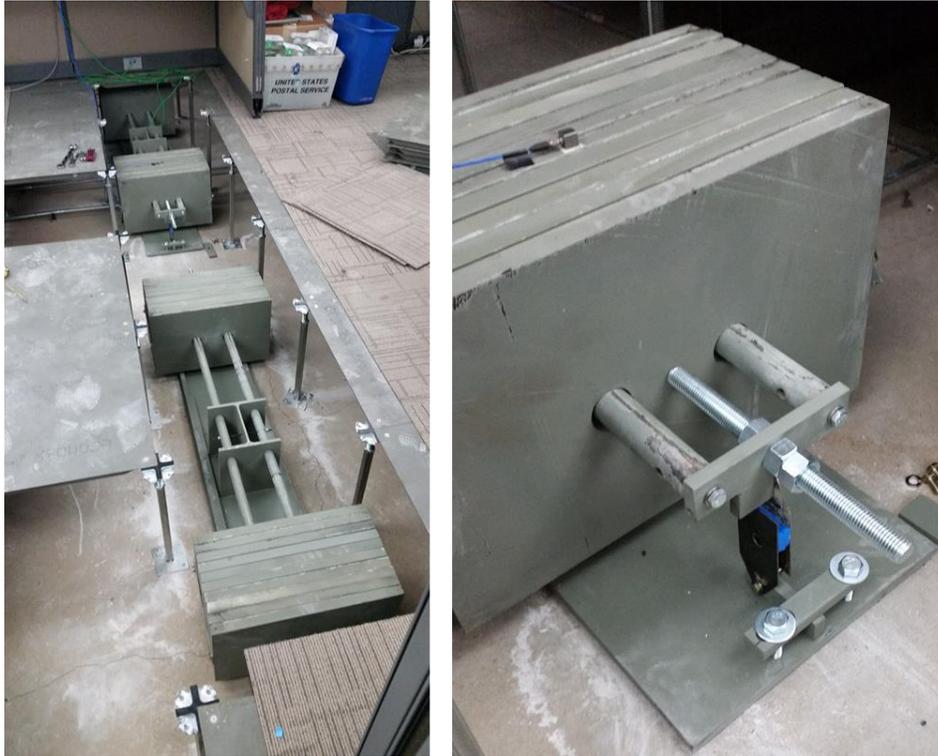
Figure 21 TMDs 3 (Far) and 4 (Near) In Place (Left) and TMD Constrained-Layer Damper (Right)

The TMD components were delivered to the site on October 1, 2015 and installed on the floor slab as shown in Figure 20 on October 3 by a local general contractor, Jones and Roberts Company. TMDs 3 and 4 are shown in their installed locations in the left-hand side of Figure 21 and a close up of one of the constrained-layer dampers is shown in the right-hand side of Figure 21. Installation only required about 4 hours. The contractor also installed plastic pedestal head gaskets (manufactured by Tate Access Floors, Inc.) on top of floor pedestals supporting panels in the primary walking path. These gaskets can be seen in Figure 21 as the black “+” elements on top of the pedestals.

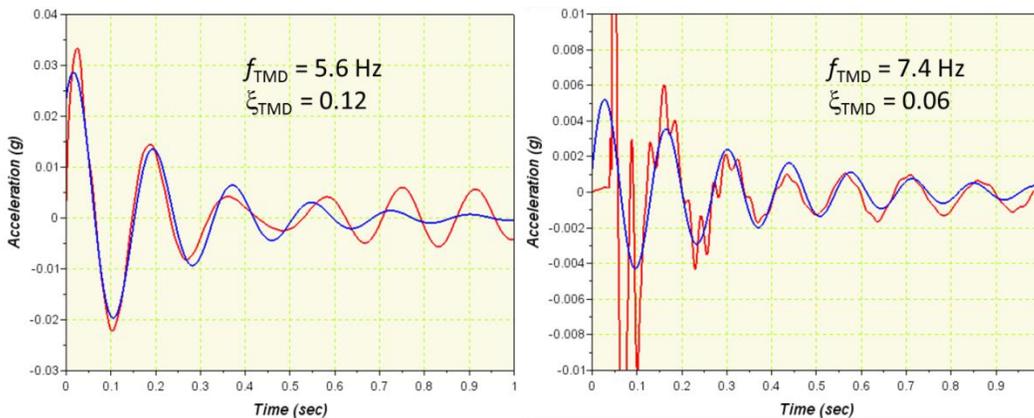
Figure 22 TMD 1 Tuning Performance, North End (Left) and South End (Right)

The TMD tuning results for both sides of TMD 1 (see Figure 20) are shown in Figure 22. The north end of the TMD performs as expected with a final resonance frequency of 5.6 Hz (close enough to the 5.7 Hz target) and a critical damping factor of 12%. The south end TMD shows anomalous results with a much higher than desired resonance frequency of 7.4 Hz and lower than desired damping factor of 6%. Both sides of the TMD are identical and the south end result is considered to be temporary and should correct itself after it has had time to “wear in” over time.

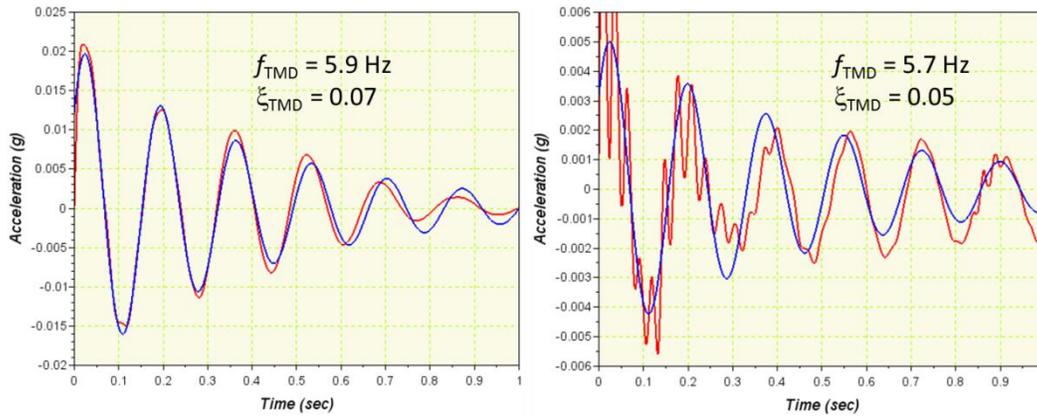
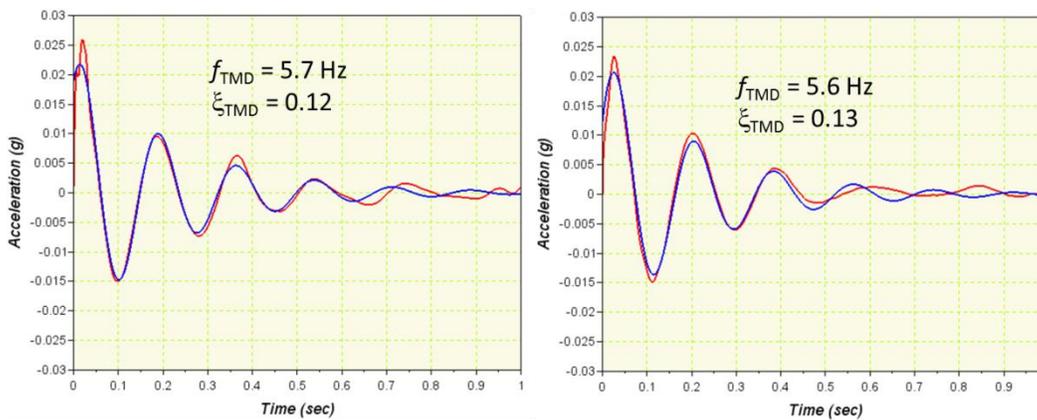
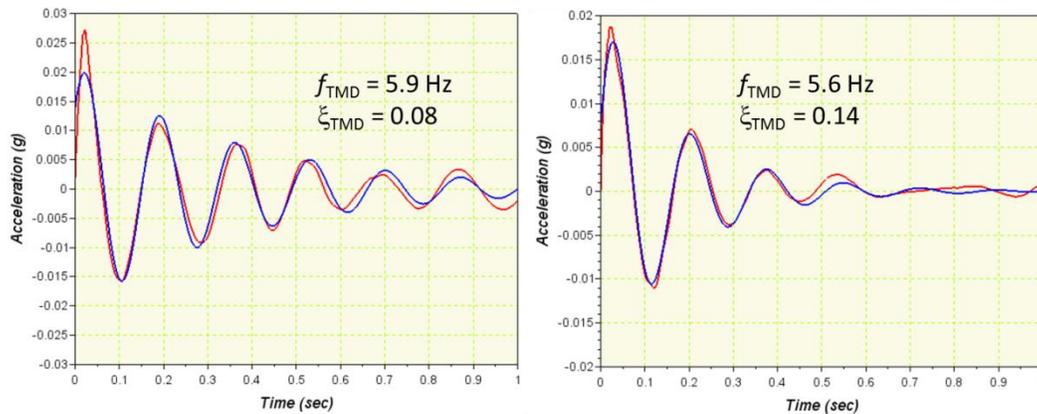
The tuning results for the remaining three TMDs are provided in Figure 23, Figure 24, and Figure 24. The results are very consistent with final tuned resonance frequencies falling between 5.6 Hz and 5.9 Hz and critical damping factors between 5% and 14%. On average, the TMDs satisfy the tuning objectives and the overall design objective and should provide 60% to 70% vibration mitigation per the performance assessment shown in the right-hand side of Figure 18.

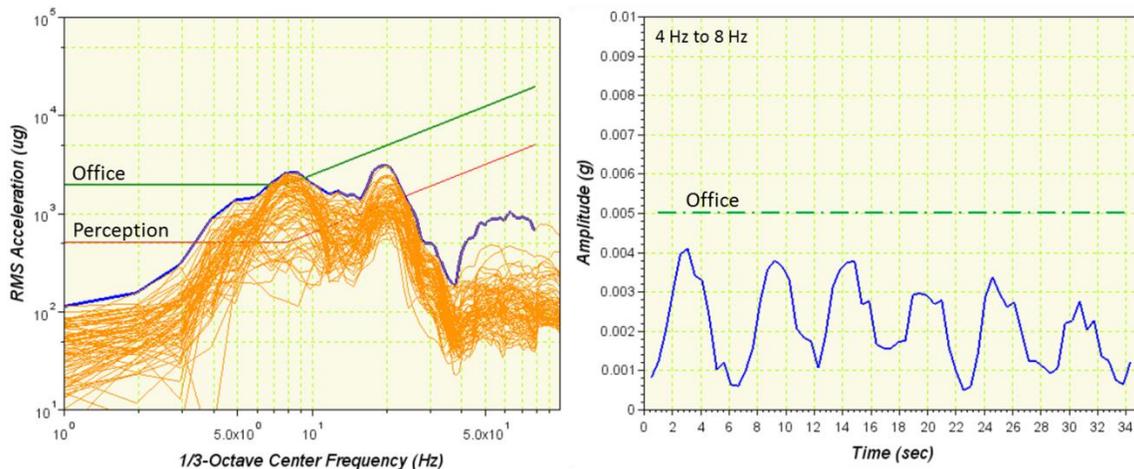
Figure 26 Walking Within Cubicle Area per 1/3-Octave Criterion (Left) and AISC DG11 Criterion (Right)

Accelerometers are placed at the locations where the maximum vibration was recorded during the site survey on July 27. Channel 1 is placed where Channel 3 is shown in Figure 12 and Channel 2 is placed at the same location as shown in Figure 12. Once again, the cell phone metronome app is used to set a walking pace of 116 steps

per minute (5.8 Hz/3) and data are recorded while walking back and forth (north and south) within the high-vibration cubicle area. The data are evaluated with the ISO and DG11 criteria and are plotted in the left- and right-hand sides, respectively, of Figure 26. The RMS vibration level at 5.8 Hz (the TMD target frequency) has dropped below the 0.002 g_{RMS} limit to 0.0015 g_{RMS} . The peak vibration envelope does exceed the office criterion near 7.6 Hz, but this is not at the frequency where the TMDs were designed to mitigate. The 7.6 Hz vibration is the 4th walking harmonic (Figure 13) and is more pronounced in these data because the very brisk walking pace exaggerates the vibration response at the walking harmonics and the floor’s resonance frequency.

The AISC criterion (right-hand side of Figure 26) shows that the peak acceleration amplitude between 4 Hz and 8 Hz reaches a maximum of only 0.004 g and does not exceed the 0.005-g limit. The 7.6-Hz vibration noted in the ISO assessment is included in this DG11 assessment and does not exceed this criterion.

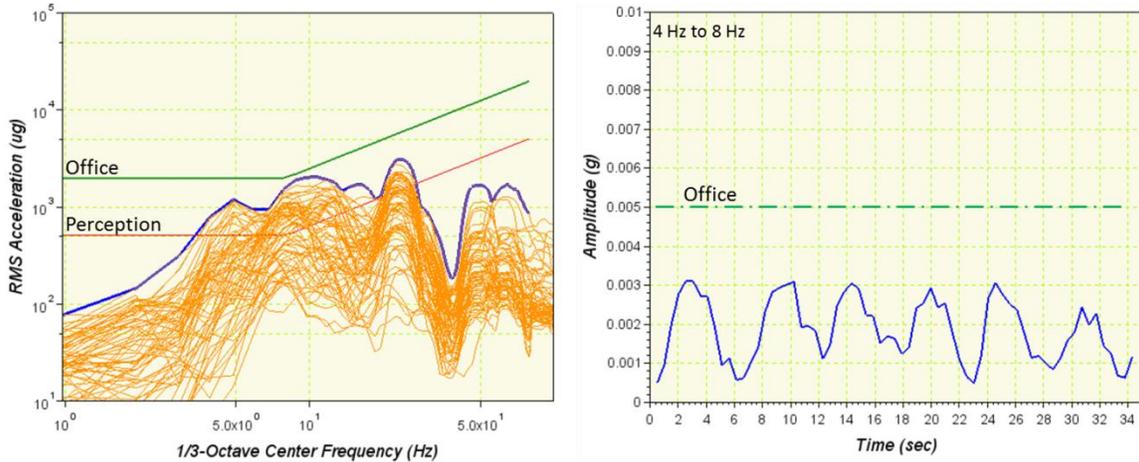
Figure 27 Walking Within Corridor per 1/3-Octave Criterion (Left) and AISC DG11 Criterion (Right)

A separate data acquisition period addresses walking back and forth (east and west) along the main corridor (left side of Figure 11) where most of the office traffic occurs. The vibration assessment for the ISO criterion is plotted in the left-hand side of Figure 27 and the assessment relative to the DG11 criterion is provided in the right-hand side of Figure 27. As expected, the vibration levels are lower in the cubicle area because the additional footfall response of the joist is not present when the walking path follows the girder span direction rather than the joist span direction.

The worst-case vibration envelope in the ISO assessment falls below the office limit across the frequency spectrum, even at the 7.6-Hz walking harmonic. The vibration levels assessed relative to the DG11 criterion also fall below the office limit of 0.005 g and are 25 percent lower than the levels measured when walking is confined to the cubicle area. Satisfying the vibration criteria for an office-type occupancy does not imply that vibration can no longer be felt in the space. The measured vibration exceeds the “perception” line shown in the ISO assessment graphs, so the building’s occupants in this area will still feel vibration.

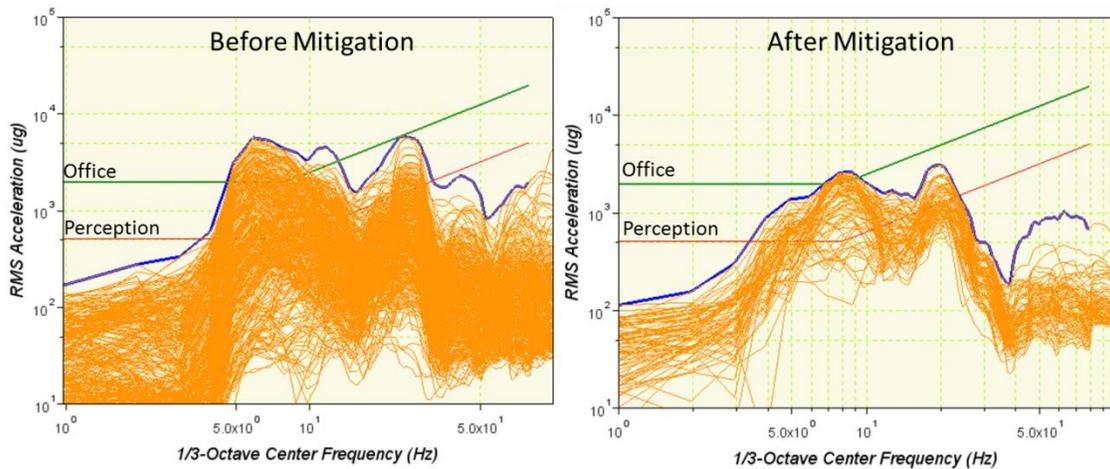
Figure 28 Comparison of Pre-Mitigation Environment (Left) and the Post-Mitigation Environment (Right)

The pre- and post-mitigation vibration assessments based on the ISO criteria are compared side-by-side in Figure 28, respectively. Before mitigation, the peak vibration at the floor’s resonance frequency was 5694 μg_{RMS} . The peak walking-induced vibration at 5.8 Hz is significantly reduced to 1460 μg_{RMS} with the TMDs in place. This comparison suggests that the TMDs have reduced the vibration by 75%, which is the maximum benefit one can expect from TMDs. Alternatively, one could assess the vibration mitigation using the DG11 criterion where

the peak vibration dropped from 0.009 g to 0.004 g, for a 55% reduction in the vibration. A fair assessment for the mitigation provided by the TMDs falls in the 60% to 70% range, which is very good.
