SEI-13036-1
January 2014

Final Report

**VIBRATION ASSESSMENT OF CRITICAL IMAGING SPACES
FOR THE NEW PARKLAND HOSPITAL**

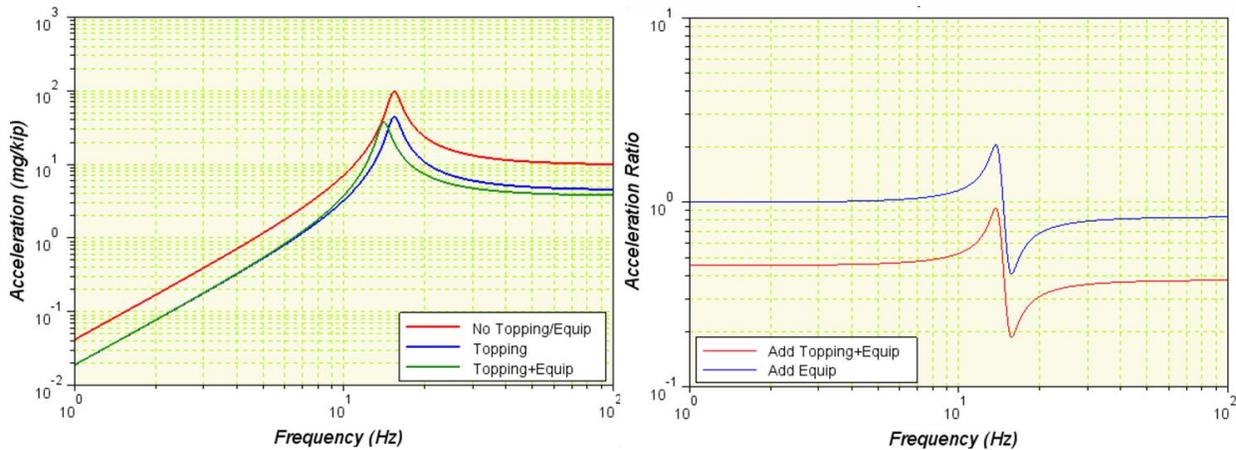
Figure 2-2 Floor System Response (Left) and Ratio (Right) With and Without Topping and Equipment.

The ratio of the acceleration response curves is shown in the right-hand side of Figure 2-2. The “Add Topping+Equip” curve on the right-hand side is the ratio of two acceleration response curves from the left-hand side of the figure (*i.e.*, Topping+Equip divided by No Topping/Equip). The “Add Equip” curve on the right-hand side is the ratio of the “Topping+Equip” and “Topping” curves on the left-hand side. Acceleration data acquired in a room without the topping (or equipment) should be scaled by the “Add Topping+Equip” curve, which reduces the vibration level across the spectrum because the magnitude of the curve is less than 1.0 for all frequencies. Data acquired in a room where the topping slab has been poured (or no topping slab will be poured) should be scaled by the “Add Equip” curve, which will increase the vibration by a factor of 2, but only near the floor resonance frequency.

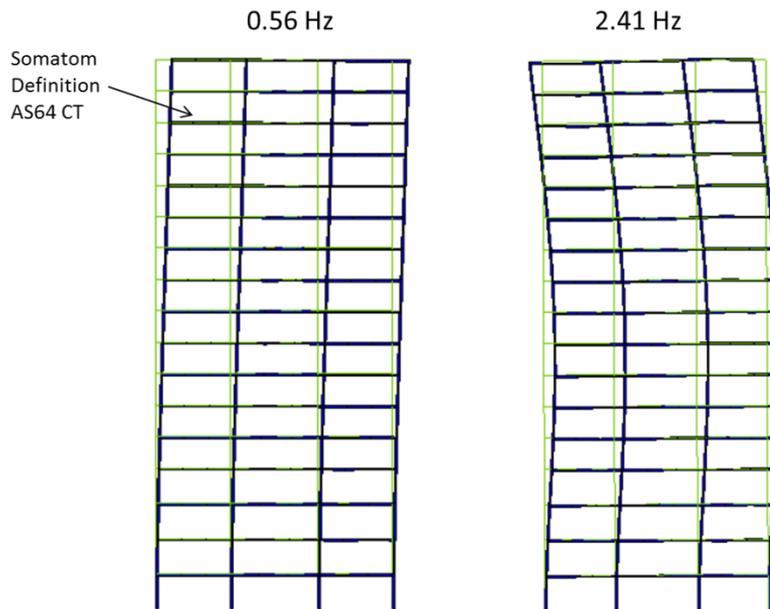
Figure 2-3 First Two Sway Modes of the Acute Tower.

Wind-induced vibration of the building is a potential issue for the Somatom Definition AS64 CT imager located on the 16th floor. The General Notes, Ref. [9], state that a vibration isolation system is required for this imager at this location in the building. A structural dynamics model of a single bay (frame) of the Acute Tower is developed to determine the amplitude of the wind-induced motion of the structure. The lateral system in the tower is a combination of reinforced concrete moment frames and shear walls. There are two box-shaped elevator core wall systems and two independent shear walls in the tower. The stiffness of the shear walls is apportioned to the single frame of interest here in proportion to its contribution to that frame. The column and beam structural properties are determined from the construction documents. The vibration modes of the frame are obtained using SDAP, Ref. [13], and the first two lateral modes are plotted in Figure 2-3.

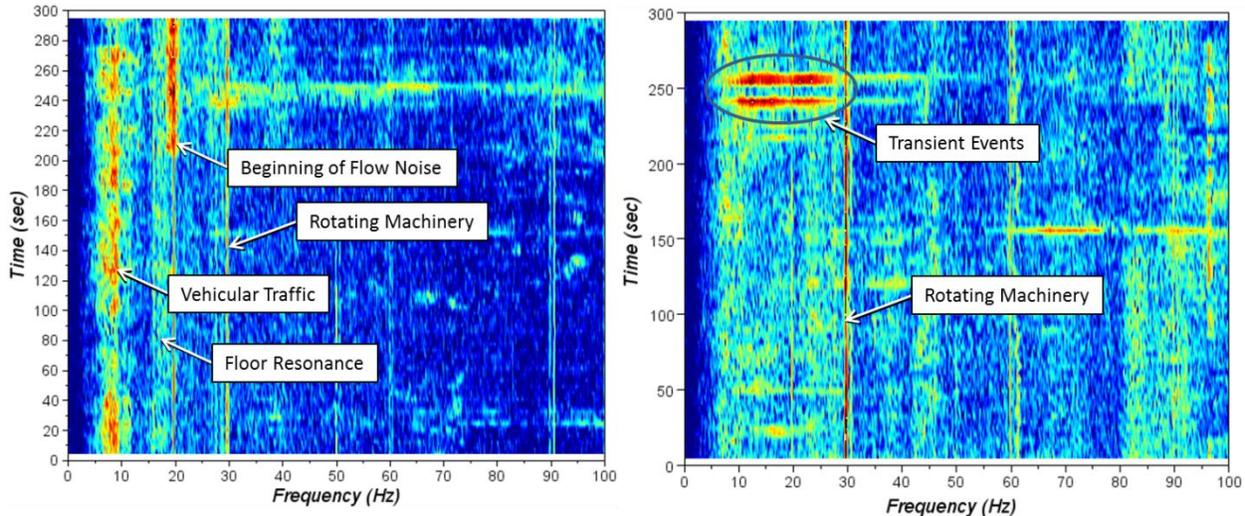
Figure 3-2 Representative Time-Frequency Spectrograms for E2122 (Left) and E4193 (Right).

Two representative time-frequency spectrograms computed from data obtained in E2122 and E4193 are provided in Figure 3-2. Thin vertical lines represent rotating machinery such as the lines highlighted in the figure at 30 Hz. A 30-Hz frequency corresponds to a motor operating at 1800 RPM. Broad vertical features may

represent amplified vibration near a floor resonance frequency or the initiation of some vibration source like the flow noise identified in the figure.

Transient events show up as horizontal features. Two transient events are identified in the right-hand side of Figure 3-2. In this case, these transient events are caused by a construction worker pushing a wheeled cart loaded with various tools and metal parts in the corridor outside the room where the measurements were being acquired. Clearly identifiable construction noise is not representative of normal hospital operation and can be ignored for the purpose of evaluating the vibration level in these rooms.
